SMEI DHU Software Patch 34

Commanding Changes

Issue 1

17 November 2004

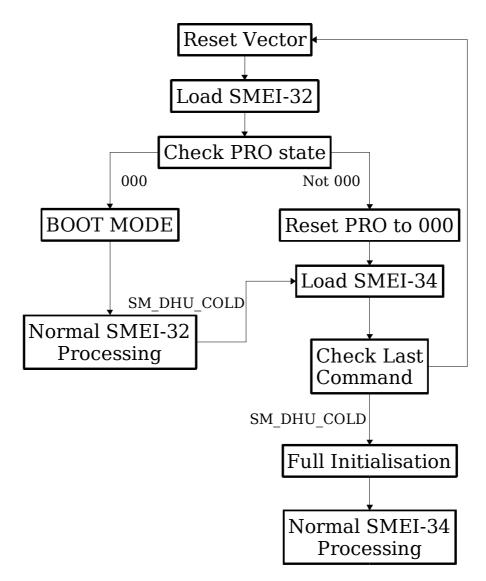
The original SMEI software has an in-built feature to attempt to resume an observation if the processor crashed after the software had been running for 4 minutes. It has been found by experience that this feature complicates the early part of the SMEI reset procedure (SMEI-05) by permitting SMEI to be in BOOT, CONFIG or OBSERVE modes after a reset pulse is applied, and to have had varying levels of re-initialisation of the DHU applied.

To rationalise the restart process to always enter BOOT mode, and to ensure a full reset was always performed, it was desired that this warm start facility was removed.

The SMEI bootstrap process was therefore modified so that the flow is as follows.
