**SMEI Instrument Onboard Data and
Software Update Procedure**

University of Birmingham

08 October 2001

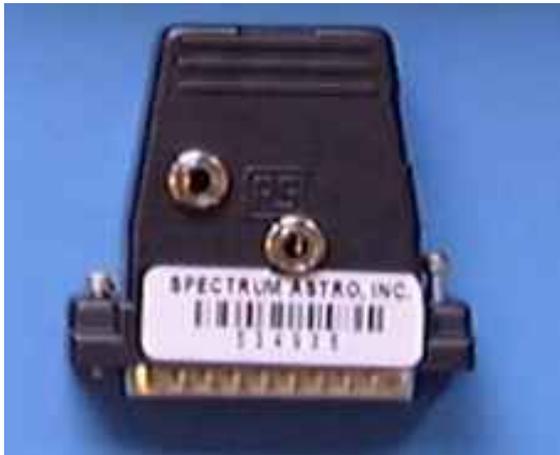
Figure 2. Program Enable Key Back

The pictures below show the SMEI DHU Program Enable Key.

In figure 2, the connector on the left is for DHU Processor Board A, and the centrally located connector is for DHU Processor Board A.

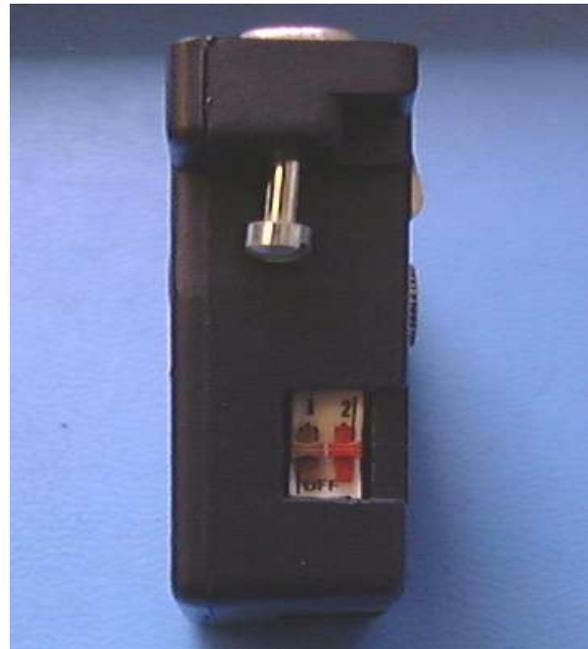
Figure 4. Write Enable And Watchdog Switches

Figure 4 shows two switches on the side of the Program Enable Key.

Switch 1 is the watchdog disable switch, and should always be left in the off position when not using the DHU in-circuit emulator.

Switch 2 is the boot e²prom write enable switch. It should be left in the off position except when indicated in the procedure.
