**SMEI Instrument Onboard Data and
Software Update Procedure**

University of Birmingham

| Issue 2

| 19 October 2001

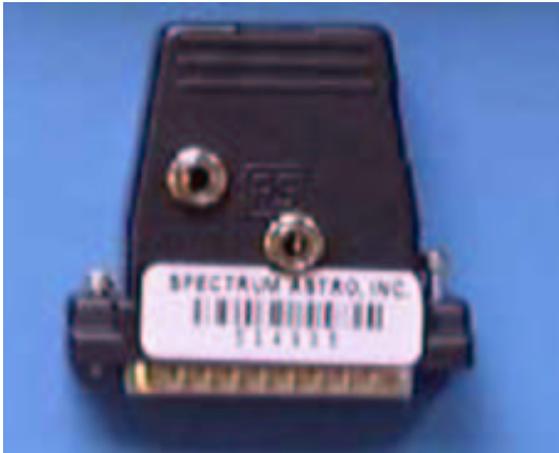
Figure 2. Program Enable Key Back

In figure 2, the connector on the left is for DHU Processor Board A, and the centrally located connector is for DHU Processor Board B.

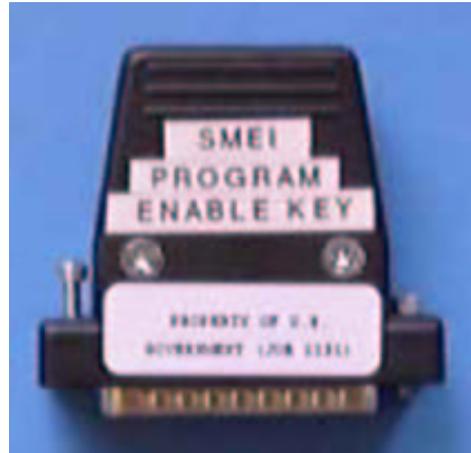
Figure 3. Program Enable Key Front

The pictures below show the SMEI DHU Program Enable Key.

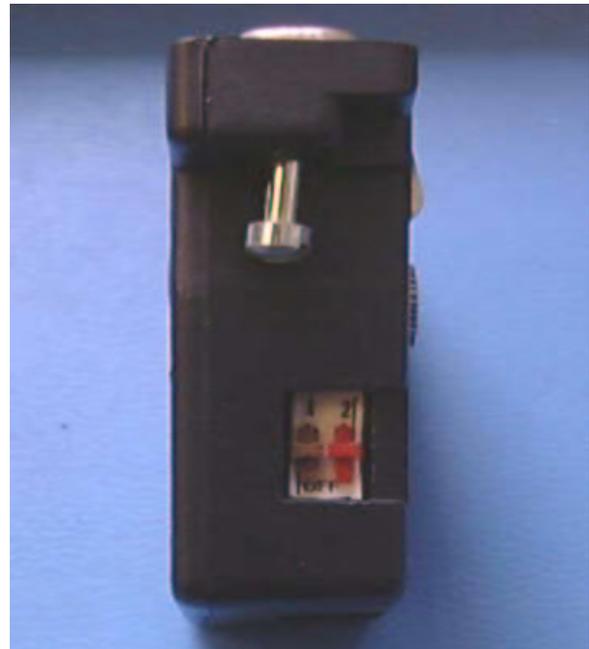
Figure 4. Write Enable And Watchdog Switches

Figure 4 shows two switches on the side of the Program Enable Key.

Switch 1 is the watchdog disable and boot e²prom write enable switch for DHU A, and should always be left in the off position except when indicated in the procedure.

Switch 2 performs the same function for DHU B.
