SST DEPARTMENT
VIBRATION TEST FACILITY
REPORT REF: AIV-2000-112A-VIB
SMEI : CAMERA F.M. 2

RUTHERFORD APPLETON LABORATORY
Vibration Facility
Chilton, Didcot,
Oxfordshire OX11 0QX

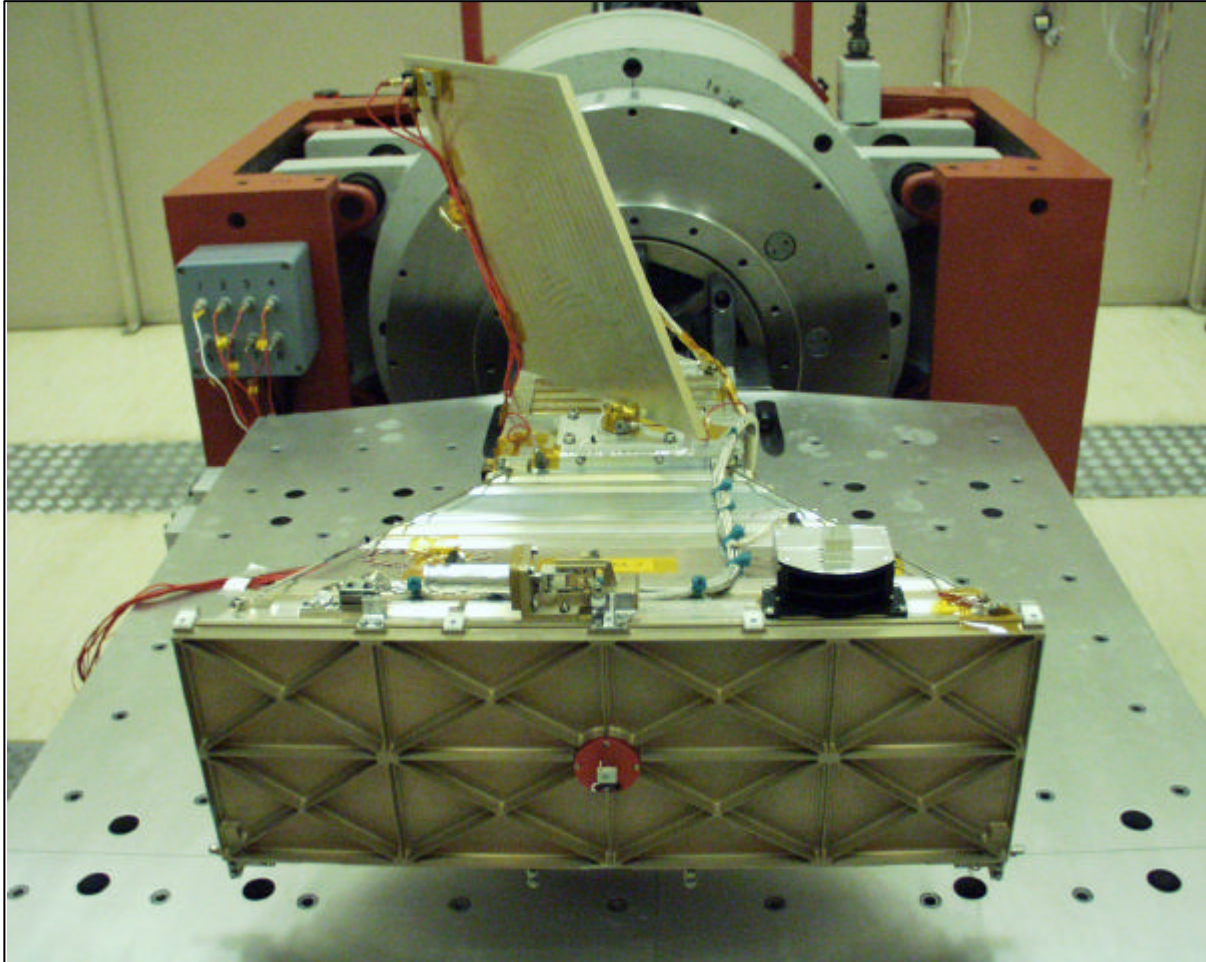
Z AXIS VIBRATION TEST CONFIGURATION

A view of the test item mounted on its vibration fixture on the slip table.

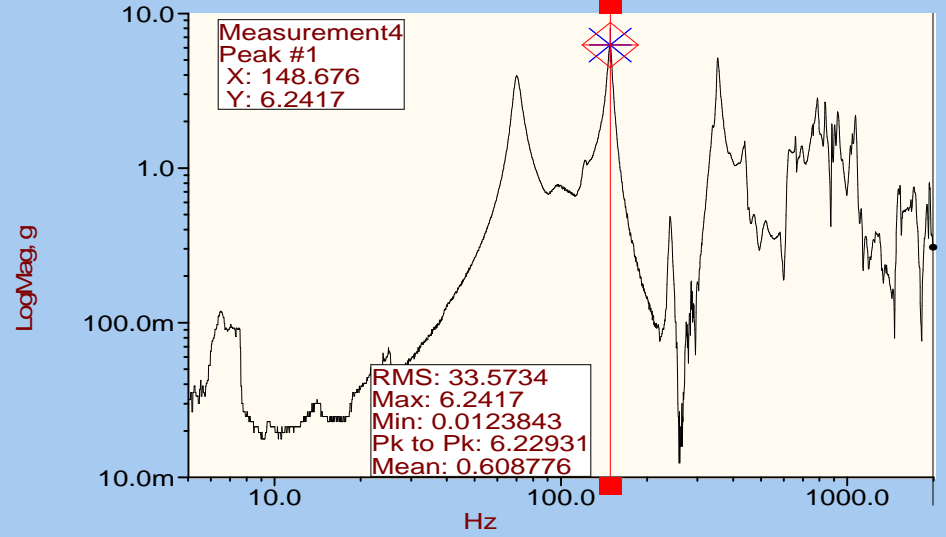
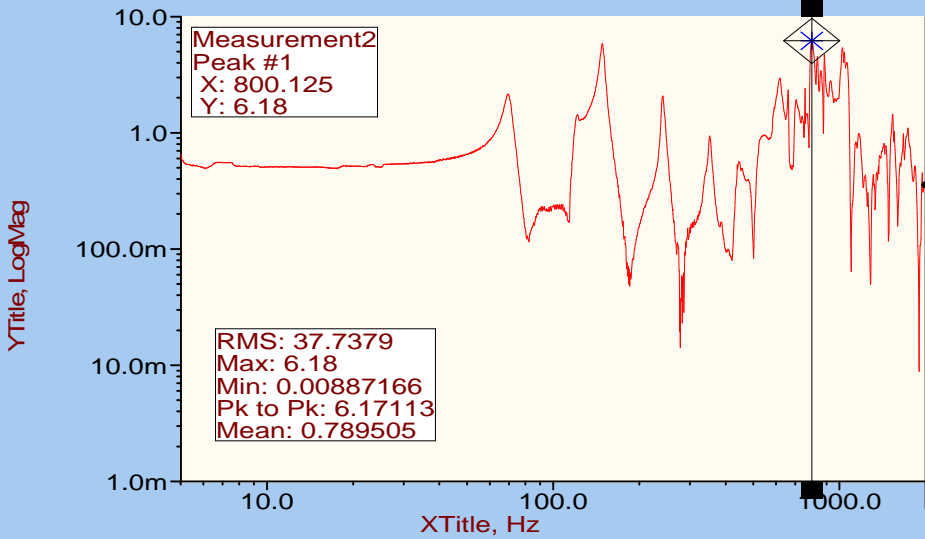
FIG 1a

TOP CORNER RADIATOR X AXIS

TOP CORNER RADIATOR Y AXIS

TOP CORNER RADIATOR Z AXIS

SMEI FM2 CAMERA SINE SURVEY
RUN 00001
Y AXIS
12:29:31 04/01/2001

RUN 00001 SINE SURVEY *FIG 1 a & b*

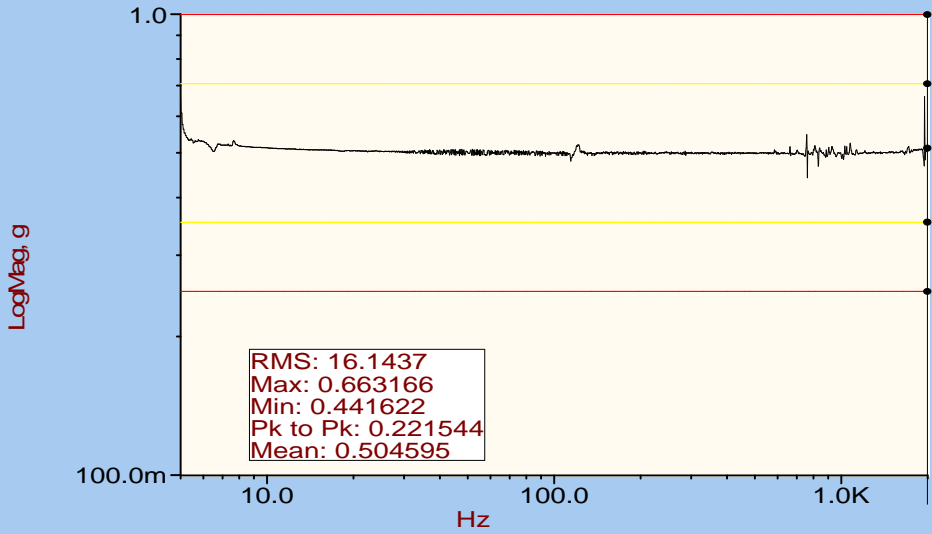
FIG 1b

REAR TOP CORNER E BOX Y AXIS

REAR END Baffle Y AXIS

TOP END COLD FINGER Y AXIS

TOP CORNER Baffle Y AXIS

SMEI FM2 CAMERA SINE SURVEY
RUN 00001
Y AXIS
12:29:31 04/01/2001

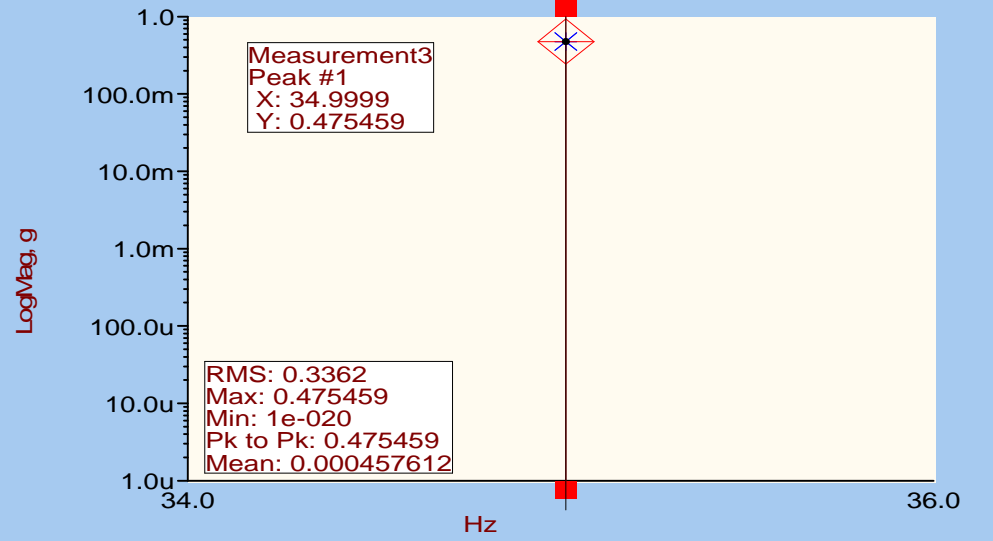
FIG 2a

SMEI FM2 CAMERA STATIC LOAD
RUN 00001
Y AXIS
12:35:34 04/01/2001

RUN 00001 STATIC LOAD *FIG 2 a & b*

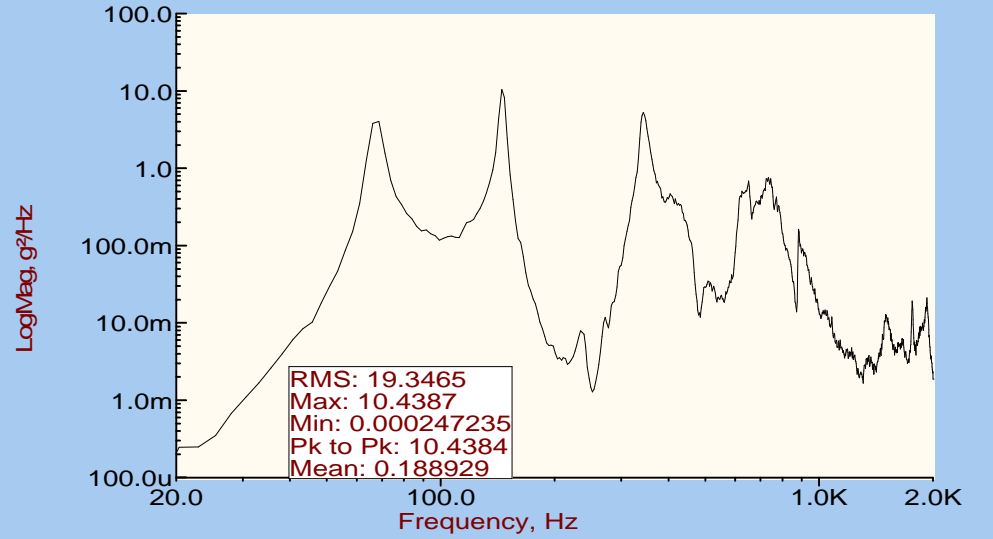
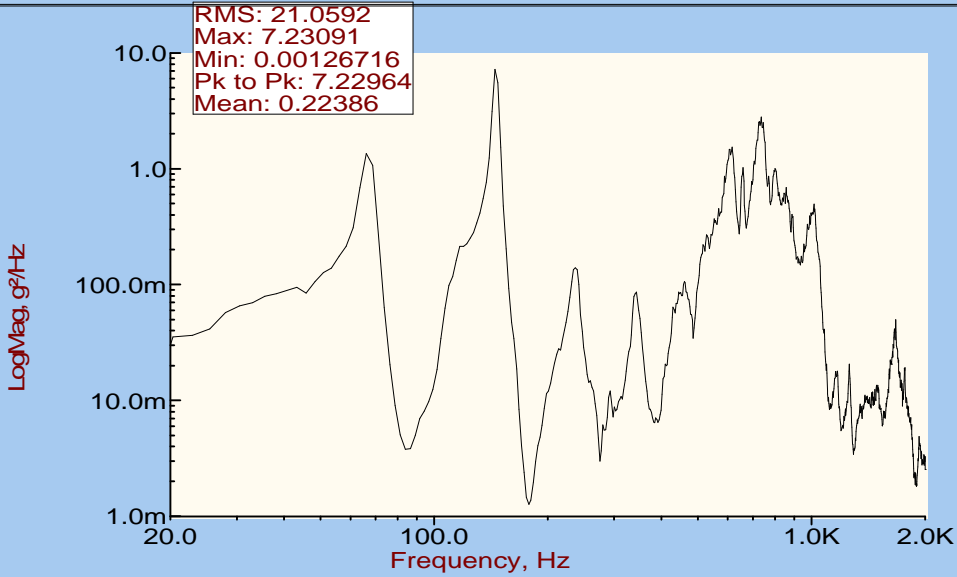
FIG 3a

SMEI FM2 CAMERA RANDOM
RUN 00001
Y AXIS
12:37:54 04/01/2001

RUN 00001 RANDOM *FIG 3 a & b*

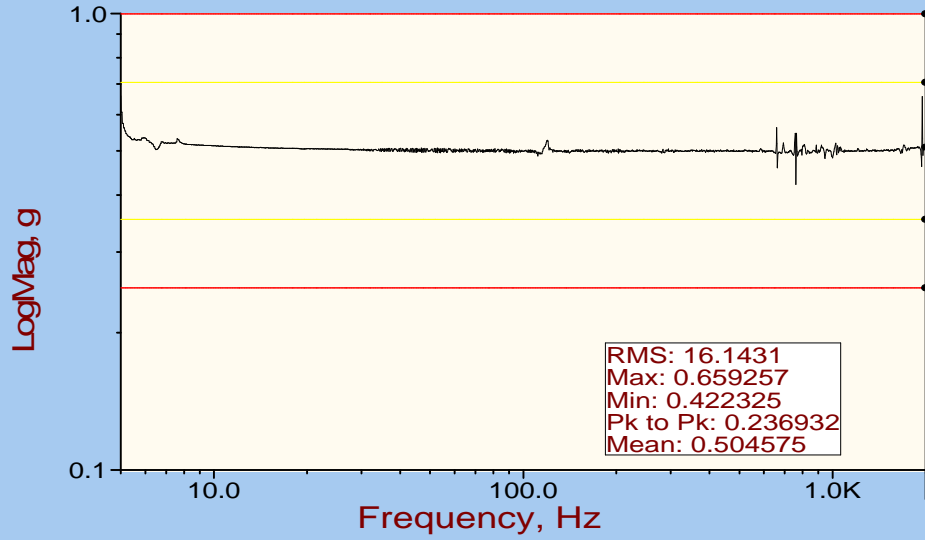
FIG 4a

SMEI FM2 CAMERA POST RANDOM SINE SURVEY
RUN 00002
Y AXIS
12:40:40 04/01/2001

RUN 00002 POST RANDOM SINE SURVEY *FIG 4 a & b*

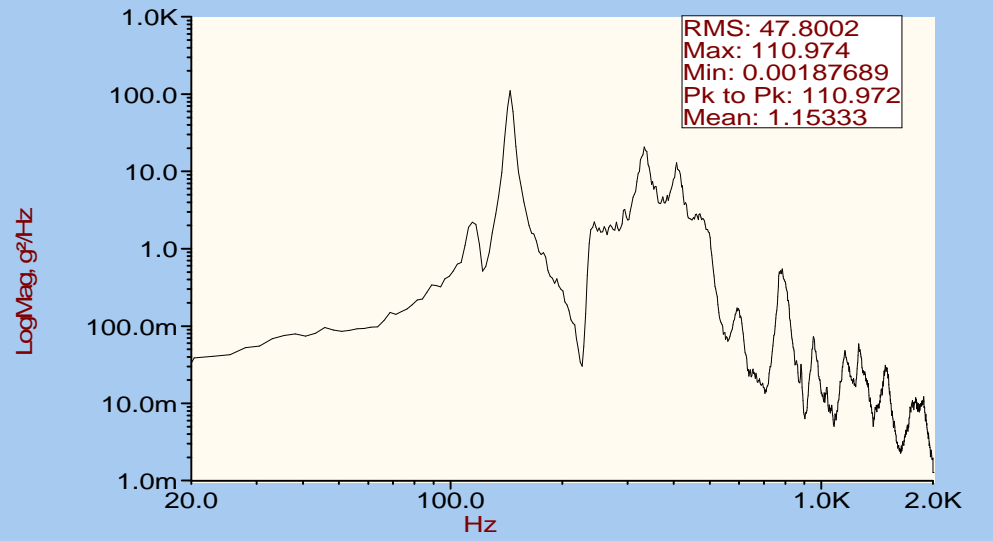
FIG 7a

SMEI FM2 CAMERA RANDOM
RUN 00002
Z AXIS
17:07:21 04/01/2001

RUN 00002 RANDOM *FIG 7 a & b*

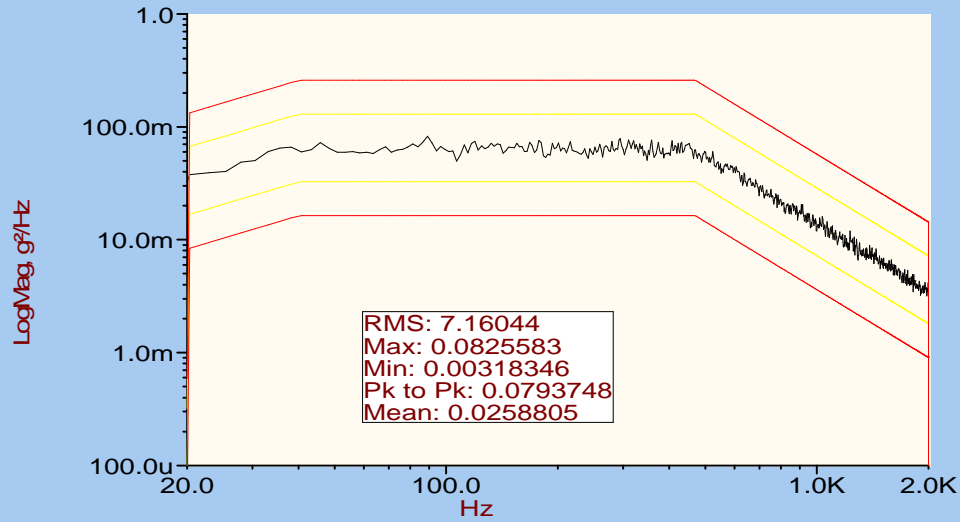
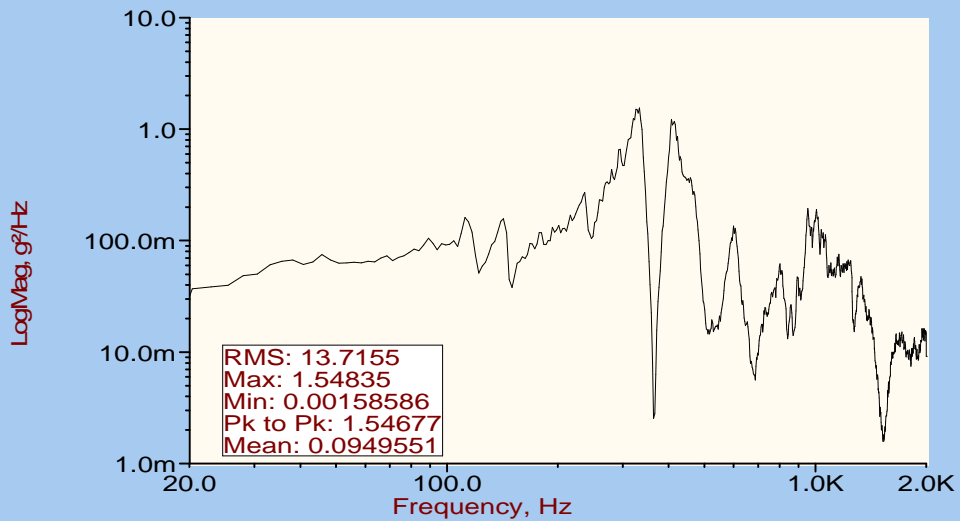
FIG 7b

TOP CORNER Baffles Z AXIS

SMEI FM2 CAMERA RANDOM
RUN 00002
Z AXIS
17:07:21 04/01/2001

During the random shake in the Z-axis (see fig 7b) the accelerometer on the top corner of the baffles came adrift from the camera. This was reattached for all subsequent runs.

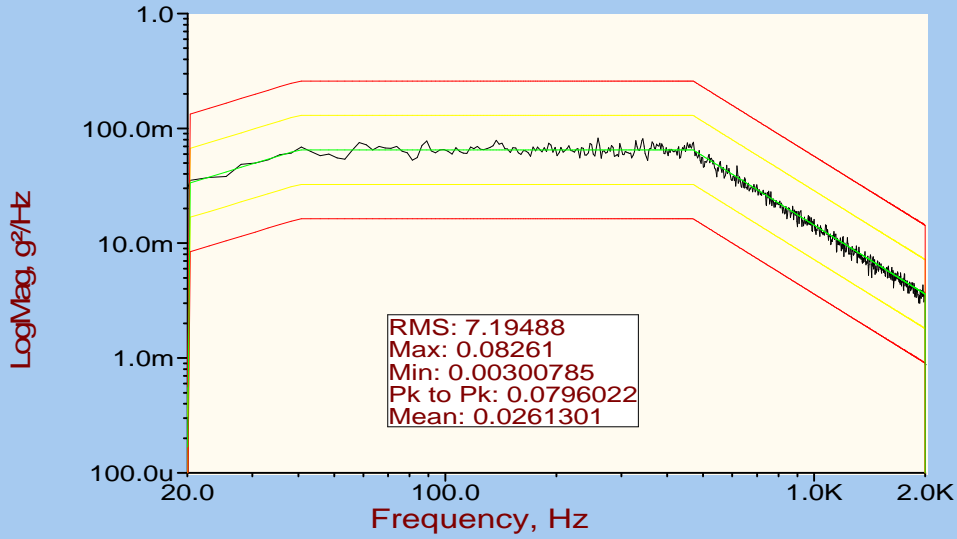
FIG 11a

SMEI FM2 CAMERA RANDOM
RUN 00003
X AXIS
10:24:21 05/01/2001

RUN 00003 RANDOM *FIG 11 a & b*
